CLEANING WORKS REPORT

FLOUR SILO A01 INTERNAL CLEANING
XYZ BAKERS – LONDON

SILO CLEANING REPORT

ISSUE: 1.0

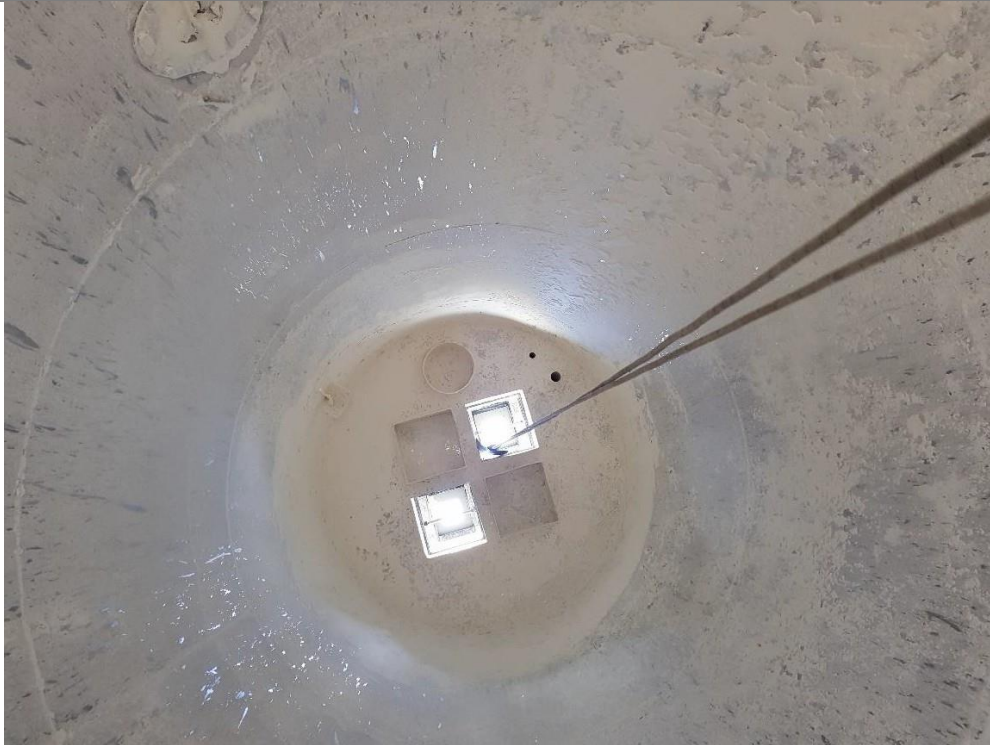
Photo No: 01 Pre-Clean: View showing accumulated deposits to the internal wall surfaces.

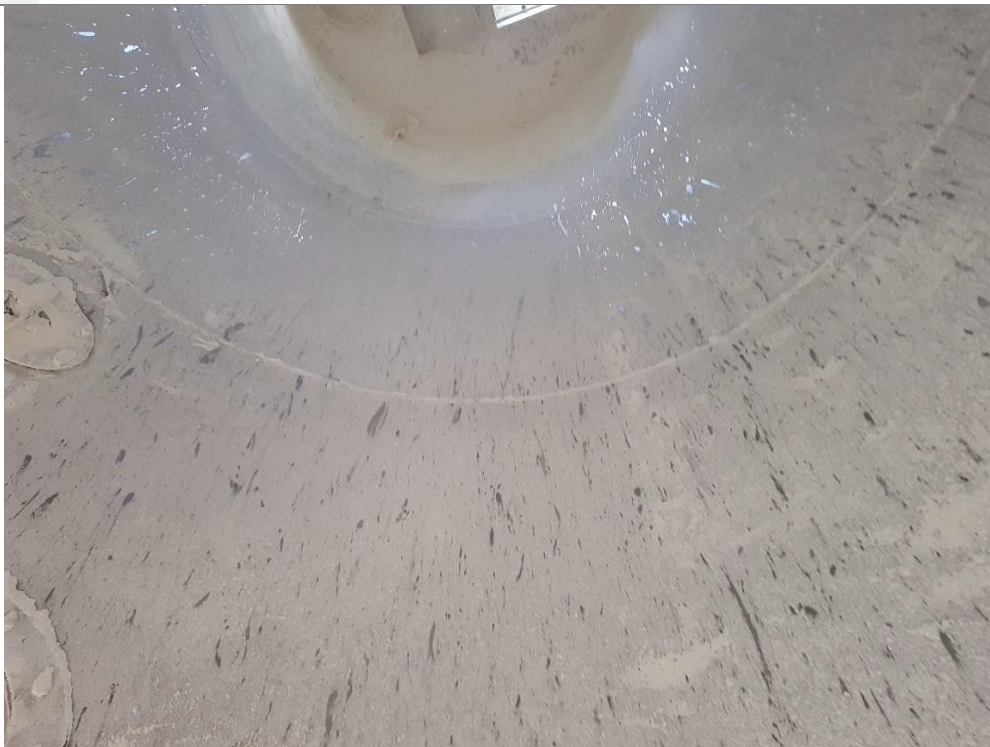
Photo No: 02 Pre-Clean: View showing accumulated deposits to the internal wall surfaces.

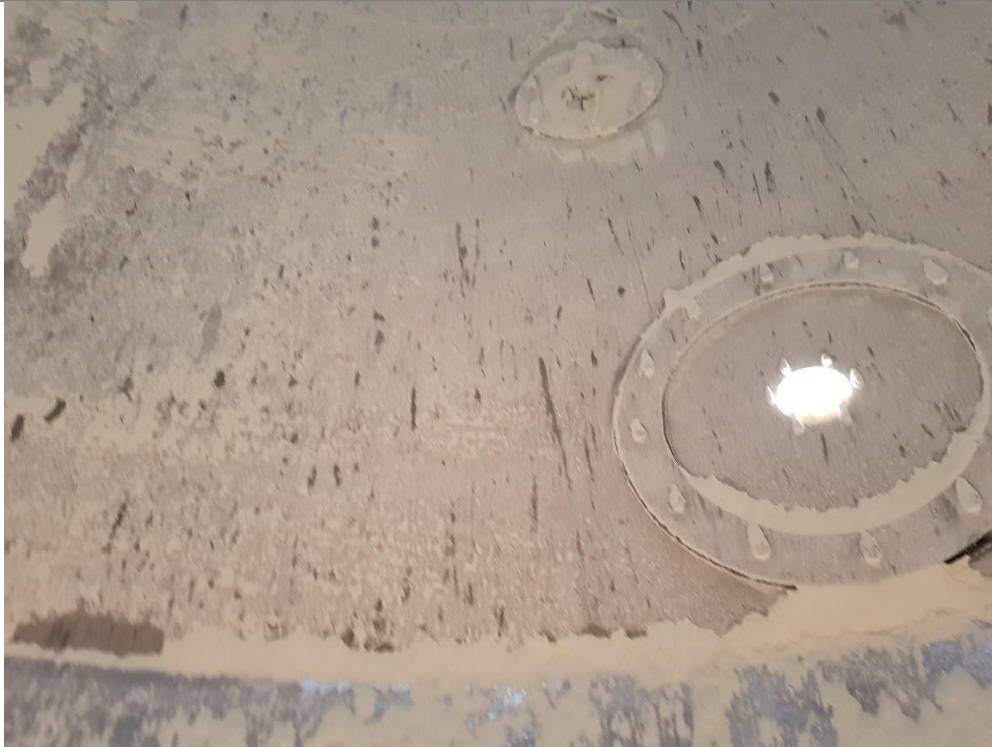
Photo No: 03 Pre-Clean: View showing accumulated deposits to the internal wall / roof surfaces.

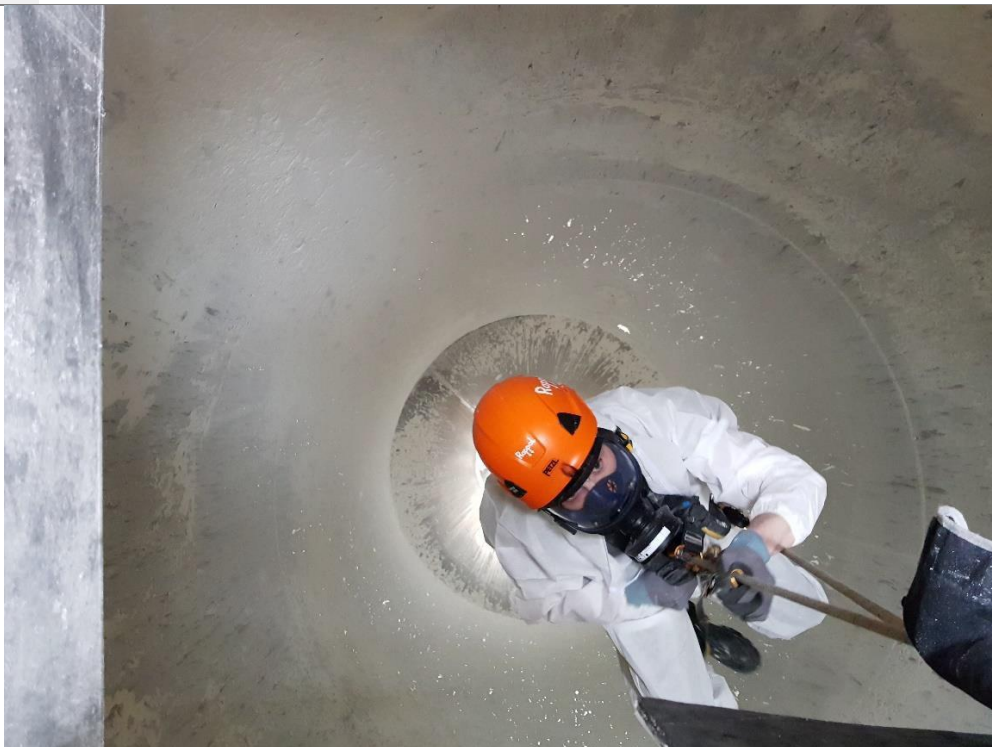
Photo No: 04 Pre-Clean: View showing pre-clean conditions.

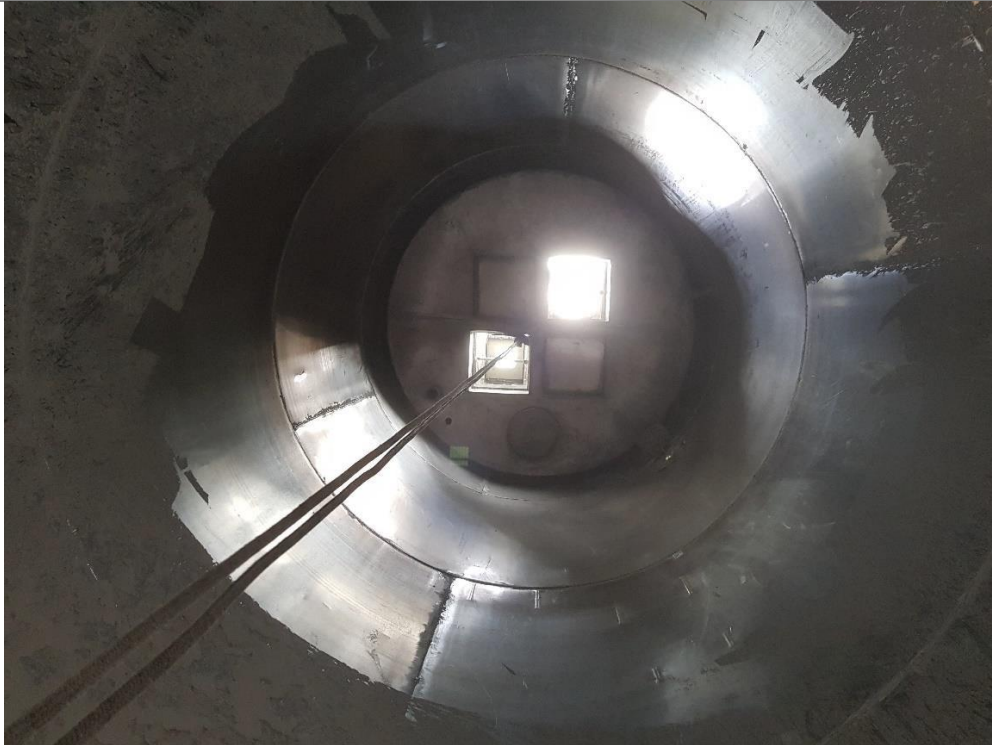
Photo No: 01 Post-Clean: View showing the cleaning works being undertaken

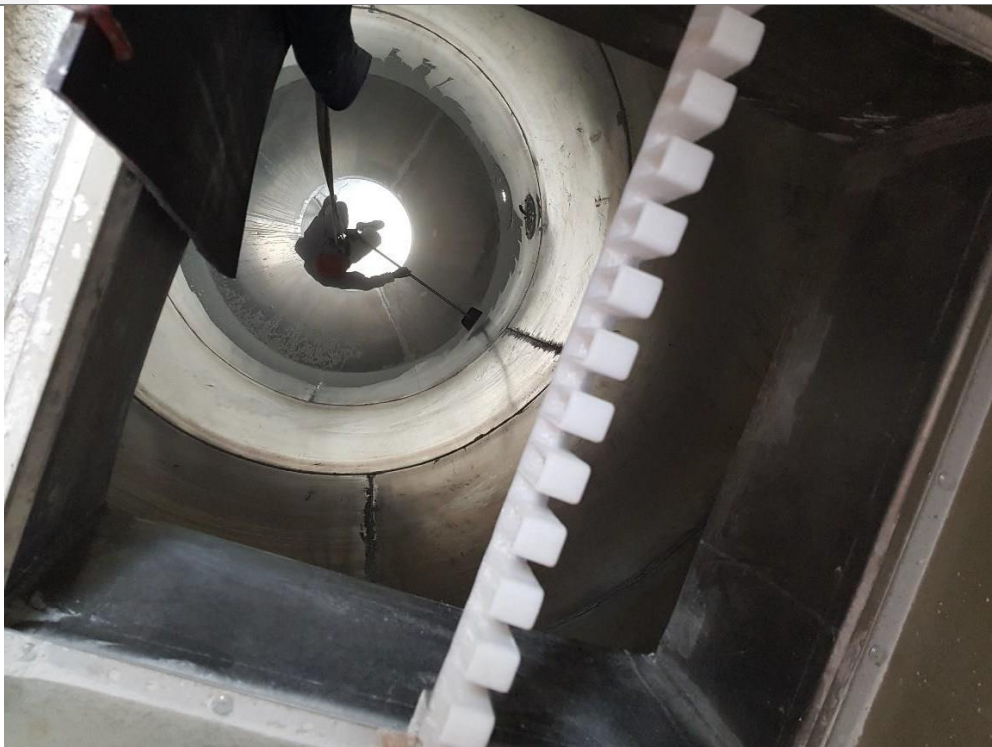
Photo No: 02 Post-Clean: View showing the cleaning works being undertaken.

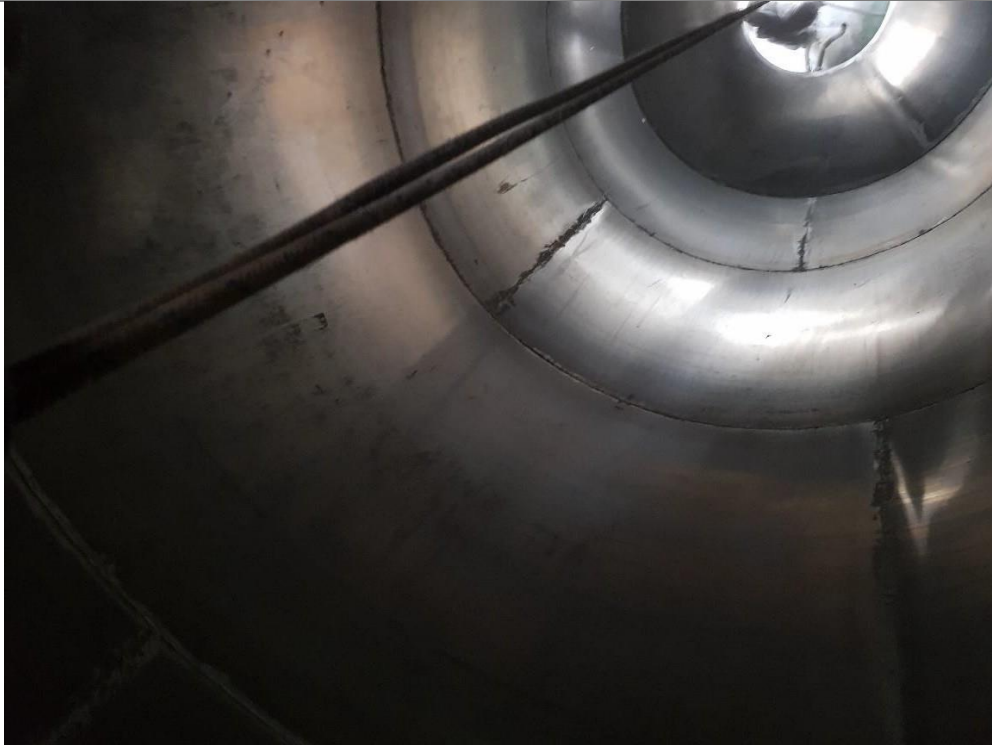
Photo No: 03 Post-Clean: View showing the silo walls after cleaning.

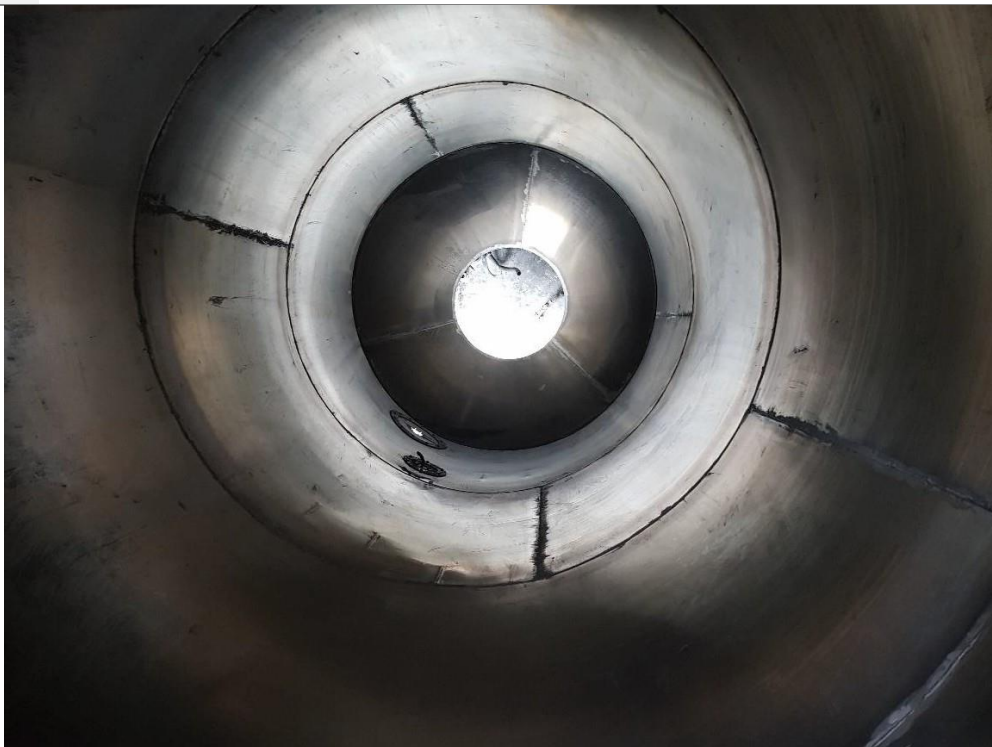
Photo No: 04 Post-Clean: View showing silo after cleaning.
